Operator's Manual

For the DM100 S-VDR

Document Number	DBS10912
Version Number	1.0
Date	October 2014
P/N (hard copy)	9302539-10

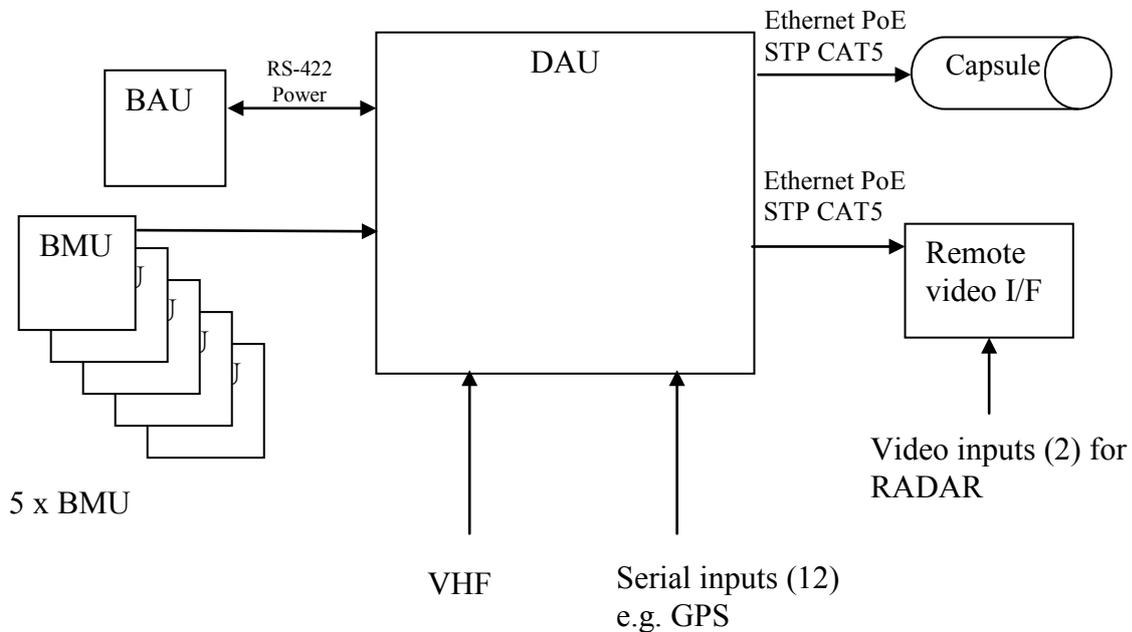
The S-VDR is composed of the following units:

S-VDR System overview (typical configuration)

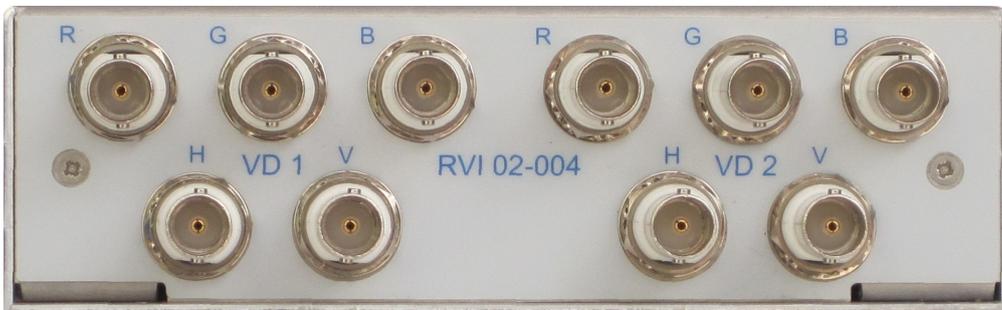
The DM100 will normally use an RVI 02-004 and RVI 02-004D for image capture. Another type exists (see section 6) which may be used if the “Power over Ethernet” ports on the DPU are used for other purposes.

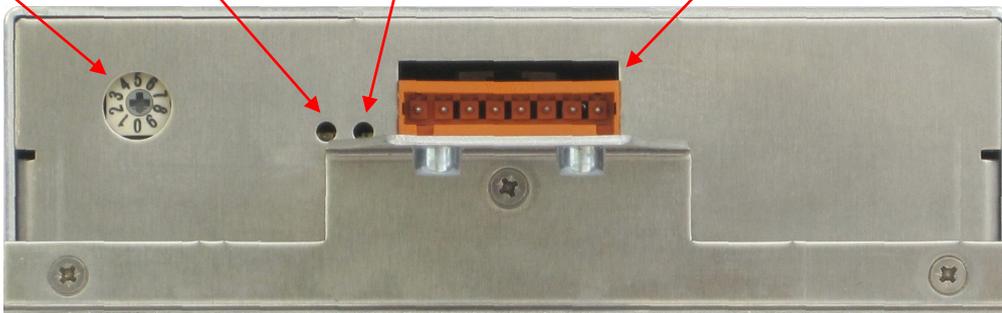
RVI address
0 or 1 (second RVI) Ethernet link and speed
(Yellow) Ethernet link and activity
(Green) Ethernet port with PoE

RVI 02-004 and RVI 02-004D rear panel

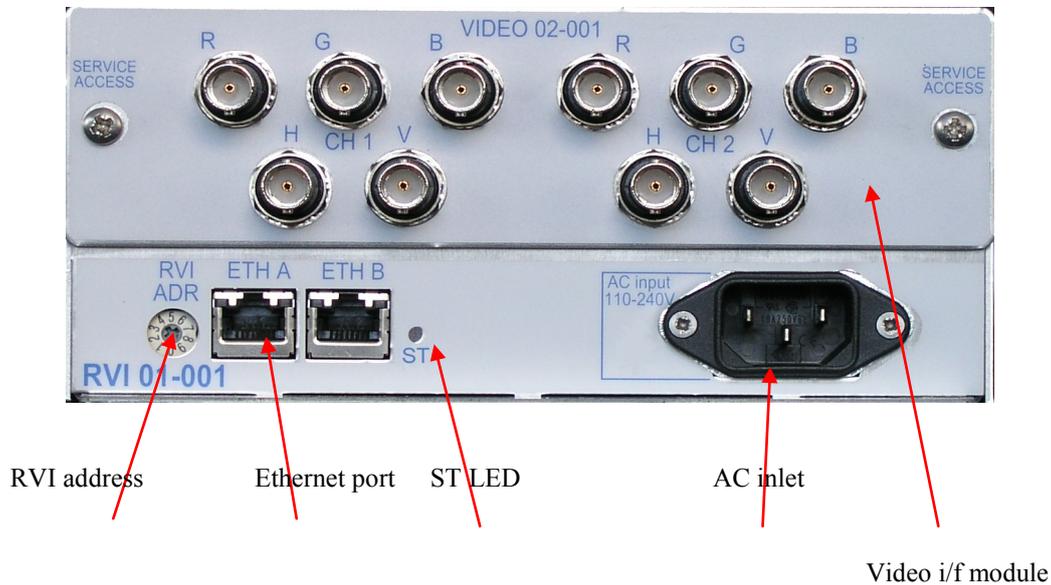
6 Operation of RVI with AC power supply

This type is only used if the “Power over Ethernet” ports on the DPU are used for other purposes.

6.1.1 RVI address

Must be set to “0” or “1” if it is the second RVI.

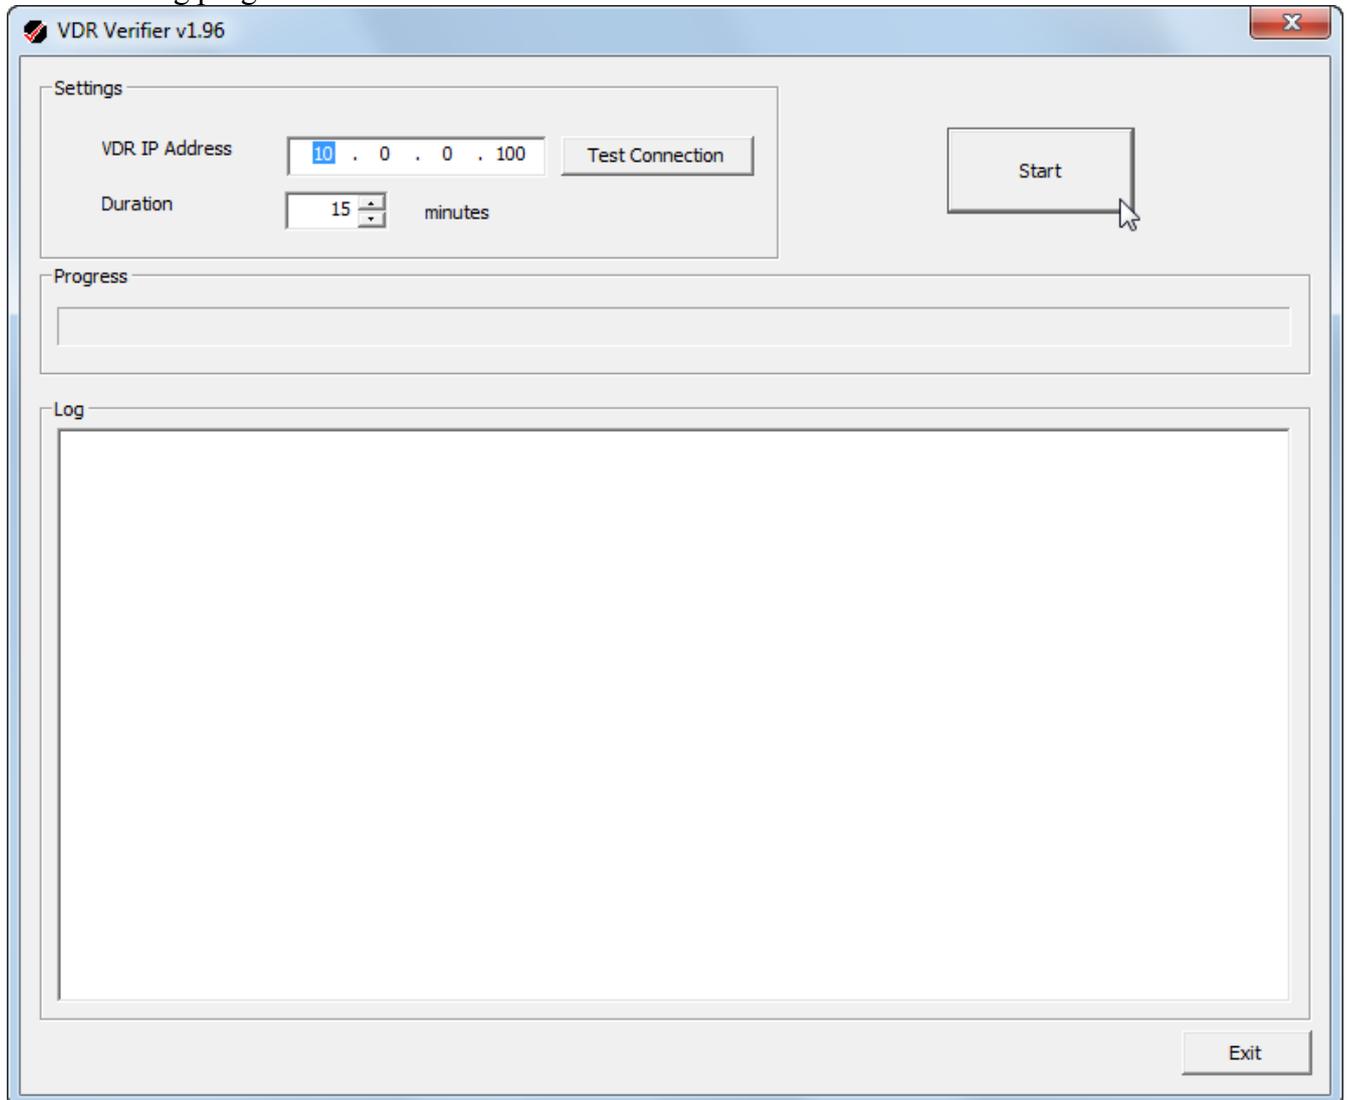
The following program will start:

If necessary, change the IP address. The default IP address is set to the default at program start.
Pressing “Test” will verify that a connection can be made to S-VDR.

Select the duration of the recording to be verified. Duration can be set from 15min to 720min.
Please notice that duration is limited to the time since the last restart of the S-VDR and that only the radar images recorded to capsule will be checked. The best result is obtained if the data to be verified was recorded during a voyage.

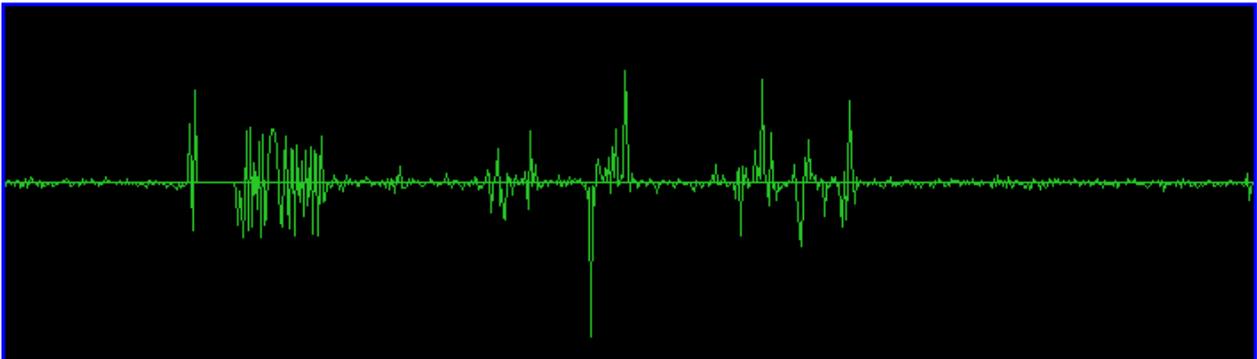
The last 60 seconds of audio

[AUDIO CH0 20110624 123040.wav](#)

Passed: The level of recorded audio was normal.

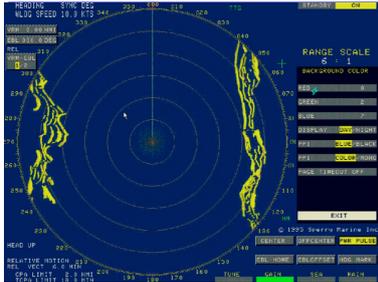
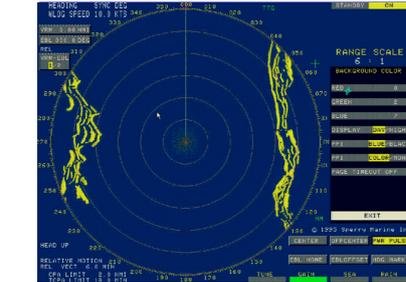
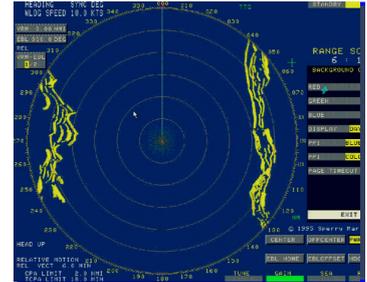
The last 60 seconds of images

[IMAGE VD01 20110624 123041.png](#) [IMAGE VD01 20110624 123056.png](#) [IMAGE VD01 20110624 123111](#)

Passed: The image contains information.
